# Double devices: Dysfunction or not?

Sok-Sithikun Bun, MD, Decebal Gabriel Lațcu, MD, Ahmed Mostfa Wedn, MD, Nadir Saudi, MD, FESC, FHRS

*From the Department of Cardiology, Princess Grace Hospital, Monaco.*

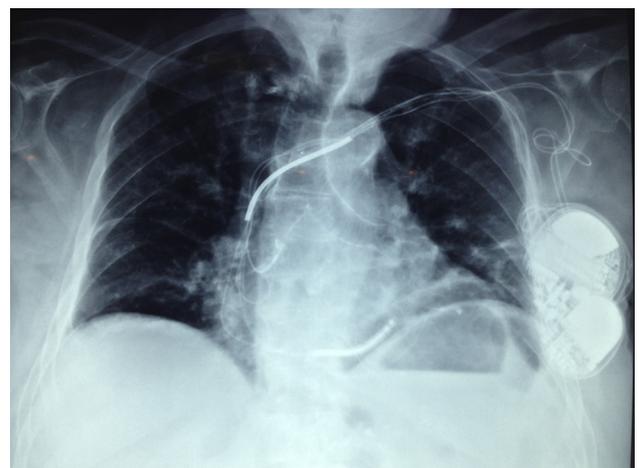
for a Medtronic AMPLIA CRT-D in another center (Figure 1), without any revision of the old battery or its leads. In May 2017, the patient was referred for a suspicious lead dysfunction; he was asymptomatic (NYHA I) and without any presyncope. A super-response was observed, with complete recovery of left ventricular ejection fraction and no more hospitalization for acute heart failure.

**Figure 1** Fluoroscopic image in anteroposterior projection showing the presence of the 2 batteries on the left side.

necessity of removing old batteries when performing an upgrade procedure.
