## TECHNICAL EXAMINATION AND RESTORATION OF THE STUCCO DECORATIONS OF AL HASAWATY MIHRĀB, FATIMID PERIOD, CAIRO, EGYPT

Abdullah M.A. KAMEL<sup>1\*</sup>, Hassan A.H. MARIE<sup>2</sup>, Hala A. Mahmoud<sup>1</sup>, Mona F. ALI<sup>1</sup>

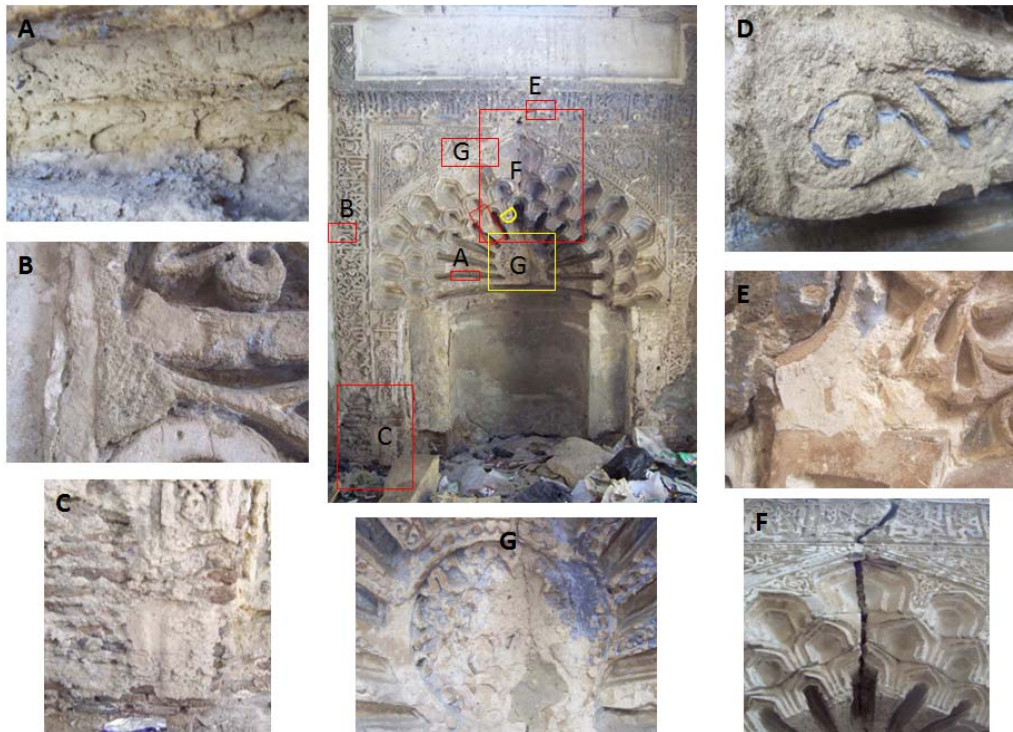
Salt layers were found in many places and at many depths of the stucco layer. In some places the salt was considered to be the binding material for the stucco layer with the red brick substrate. The salt layer in some parts was stronger than the stucco layer, which will help in abstracting the salt layer without affecting the fragile stucco layers. The X.R.D analysis results showed that this salt layer consists of sodium chloride (water soluble salt) (Fig. 3a). As indicated in the literature, soluble salts are considered to be among the most important causes of decay. Salts cause damage by the growth of salt crystals within the pores, which can generate stresses that are sufficient to overcome the tensile strength of the material and turn it to powder [2].

The loss of mihrāb stucco can be divided into three: complete loss of the stucco layer, loss of the surface layer of stucco decoration and degradation of the surface of stucco decoration (Fig. 3c and d).

The old restoration of the lower part of the mihrāb was done by using strong Portland cement mortar; also, strong Portland cement mortar patches were noted among the fragile stucco motives and as splashes on the surface of the stucco (Fig. 3b and g).

These mortars were used in filling the large crack at the center of the mihrāb, many decorations disappeared because of these mortars, also, gypsum mortar was used in completing the missing upper parts of the mihrāb, and there was spreading of gypsum spots on the stucco decoration of the mihrāb (Fig. 3e).

Cracks and fissures were found in many parts of the mihrāb, they ranged from small fissures to large cracks (Fig. 3f and g), these cracks may relate to substrate movement and the heterogeneity of wall materials differing both in porosity and thermal conductivity [3-8].

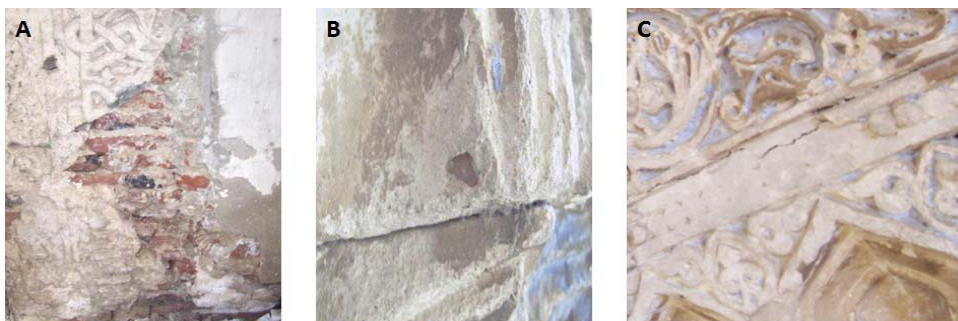
**Fig. 4.** The application of different treatments: a & b - direct application of stucco mortar and engraving, c - application of two stucco layers on the substrate

The following pictures show that the decoration of the Al Hasawaty mihrāb was executed by direct application of stucco mortar on the red brick substrate after which the stucco motives were engraved onsite. In the spandrels two layers of stucco were applied on the substrate; the first layer is flat plaster and the other layer bears the engraved motives (Fig.4).

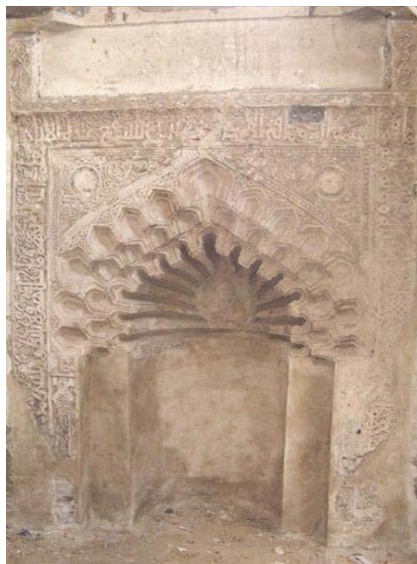
Fig. 12. Al-Hasawati stucco mihrāb after the consolidation

In figure 12 is presented the image of the Al-Hasawati stucco mihrāb after the consolidation treatments.
