CHARACTERIZATION OF CONSTRUCTION MATERIALS OF THE HISTORIC STRUCTURES IN HISTORIC CAIRO: A CASE STUDY

The paper presents a comprehensive experimental programme aimed at the characterization of the construction materials of the Fatima Khatun Mausoleum in Historic Cairo, built in the 13th century. The mausoleum reached an advanced state of degradation and, in short, turned into a garbage dump. A joint research project between Egypt and the United Kingdom was launched, aiming at its conservation in general and proposing guidelines for the management and conservation of historic Cairo. Representative samples were collected from the limestone, the historic and new bricks used in a previous restoration, the mortar, and the salt. The physical, chemical, petrographic, and mechanical properties were determined experimentally. It can be claimed that the construction materials of the mausoleum were characterised to a good extent, which will help in any future intervention when choosing new limestone, mortar, and bricks to select compatible materials with the historic ones.

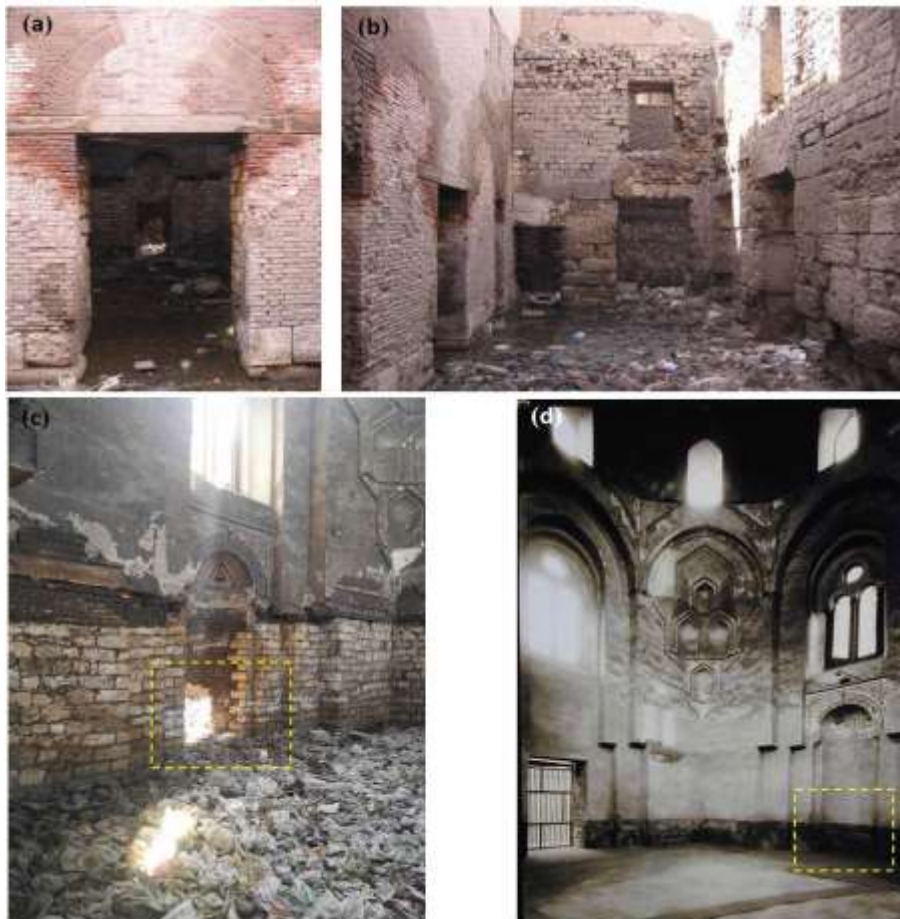
Fig. 1. Current situation of Fatima Khatun Mausoleum: (a) high groundwater penetration by capillarity in masonry walls; (b) local damages and accumulation of groundwater and garbage; (c) garbage dump inside the mausoleum and partial collapse of a wall; (d) historic photo showed no deterioration (source: Creswell collection) [26])

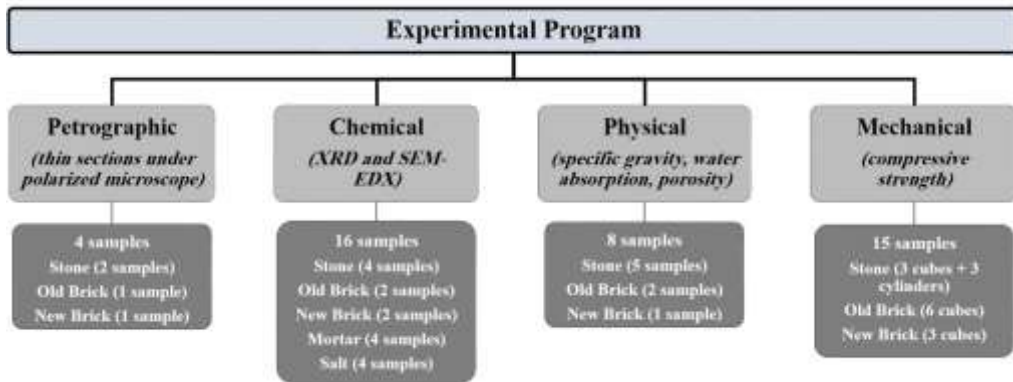
Fig. 3. Scheme of the implemented experimental programme: type of tests and number of samples in each test

The necessary samples were collected from the different construction materials and deterioration products, including the limestone, the old brick, the new brick, the mortar, and the crystallised salt. The experimental programme (Fig. 3) included measuring the physical properties of the bulk specific gravity, the water absorption, and the porosity of the limestone (five samples), the old brick (three samples), and the new brick (three samples). The petrographic analysis included two samples of the limestone, one sample of the old brick, and one sample of the new brick.

The chemical analyses consisted of XRD and SEM-EDX. The XRD examination considered two samples of each of the limestone, the mortar, and the salt, and one sample of each of the old brick and the new brick. Similarly, the SEM-EDX examination was performed on two samples of each of the limestone, the mortar, and the salt, and one sample of each of the old brick and the new brick. Finally, mechanical testing of the compressive strength was carried out on 15 samples. From the limestone, three cubes and three cylinders were tested. From the old brick and the new brick, six and three cubes were tested, respectively. In total, 43 samples were employed in all the examinations, analyses, and tests that were performed at the rock engineering laboratory of the Faculty of Engineering at Cairo University.

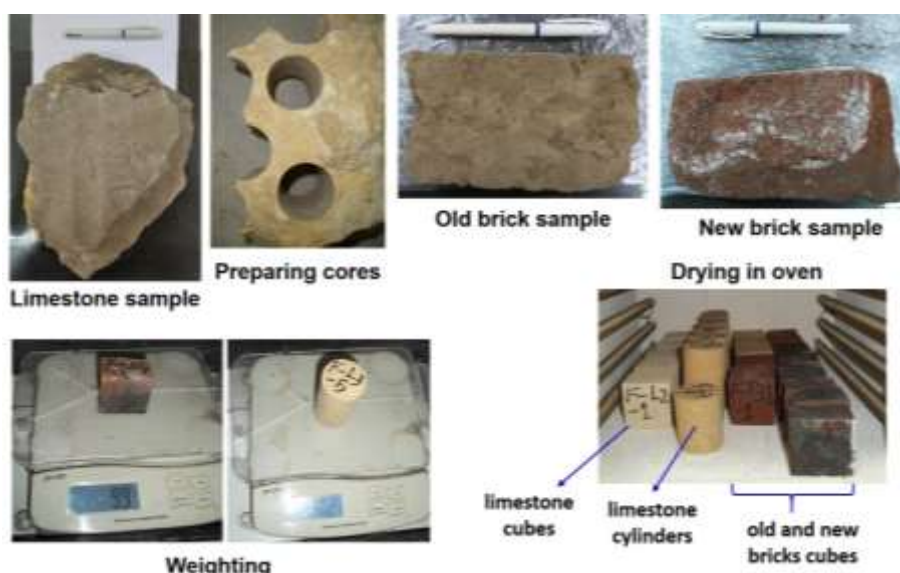
Fig. 10. Different photographs depict various raw samples, preparations, and tests.

The tests of the limestone were carried out following the ASTM standard C97/C97M-18 [30], and for the bricks, the ASTM standard C67/C67M-20 [31, 32] was followed. The collected limestone samples were prepared in either cubes with a length of 50mm or cylinders with a diameter of 44mm and a height of 88mm (Figure 10). The old brick and the new brick samples were prepared in cubes with a length of 50mm (Figure 10). Table 2 summarises the obtained results.

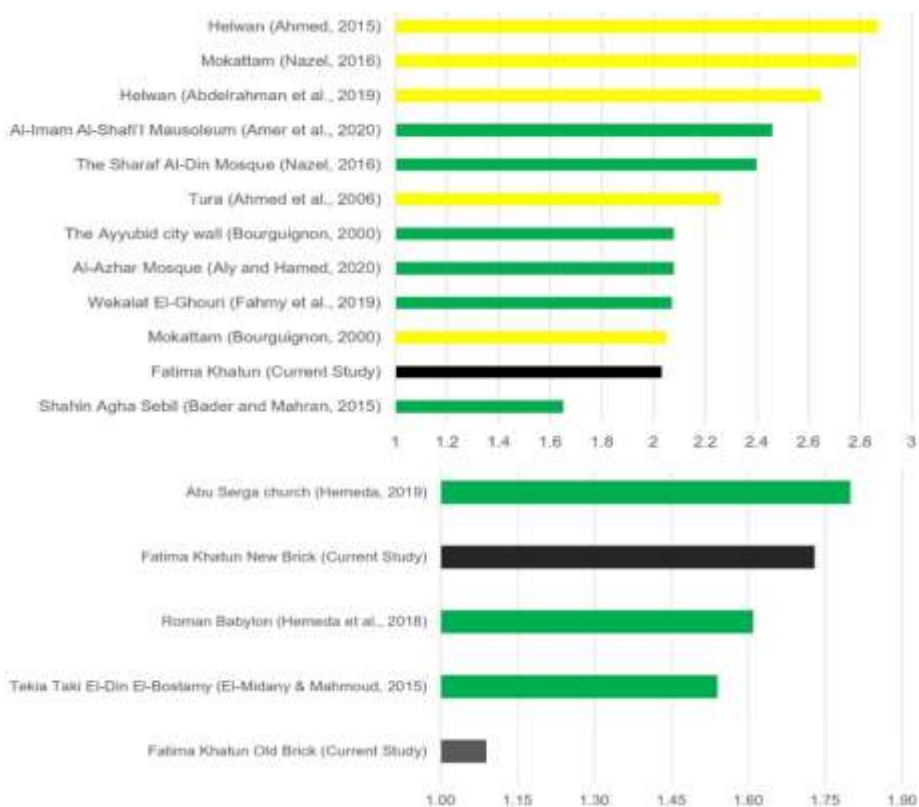
Fig. 11. Comparison of the bulk specific gravity (-) with the literature for the limestone (top) and the brick (bottom).

A comparison was made with the previous studies in which limestone samples were extracted and tested. These studies were found to be relatively limited. The limestone specimens were extracted from either the quarries utilised to build the historic structures in Cairo, namely Helwan, Mokkatam, or Tura. In addition, the results of specimens extracted from some other historic structures in Historic Cairo were considered, specifically the mosques of Al-Azhar and Sharf Al-Din, the mausoleum of Al-Imam Al-Shafi'I, the Sebil of Shahin Aga, Wekalat Al-Ghour, and the Ayyubid City wall. The comparisons were plotted for the bulk specific gravity (Fig. 11), the water absorption (Fig. 12), and the porosity (Fig. 13). As can be noticed, the obtained results are comparable with the literature for the three physical properties.

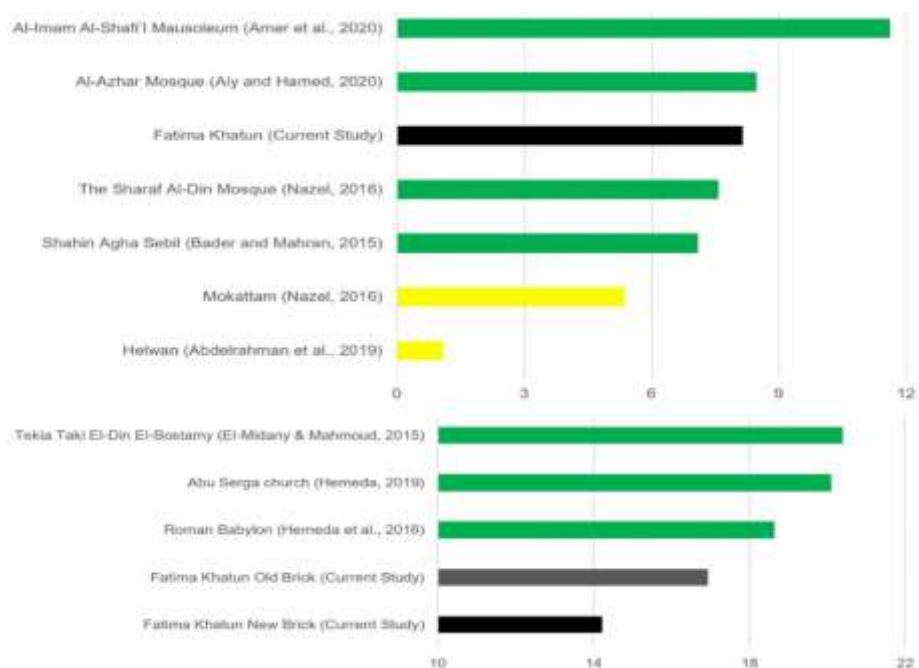
Fig. 12. Comparison of the water absorption (%) with the literature for the limestone (top) and the brick (bottom).

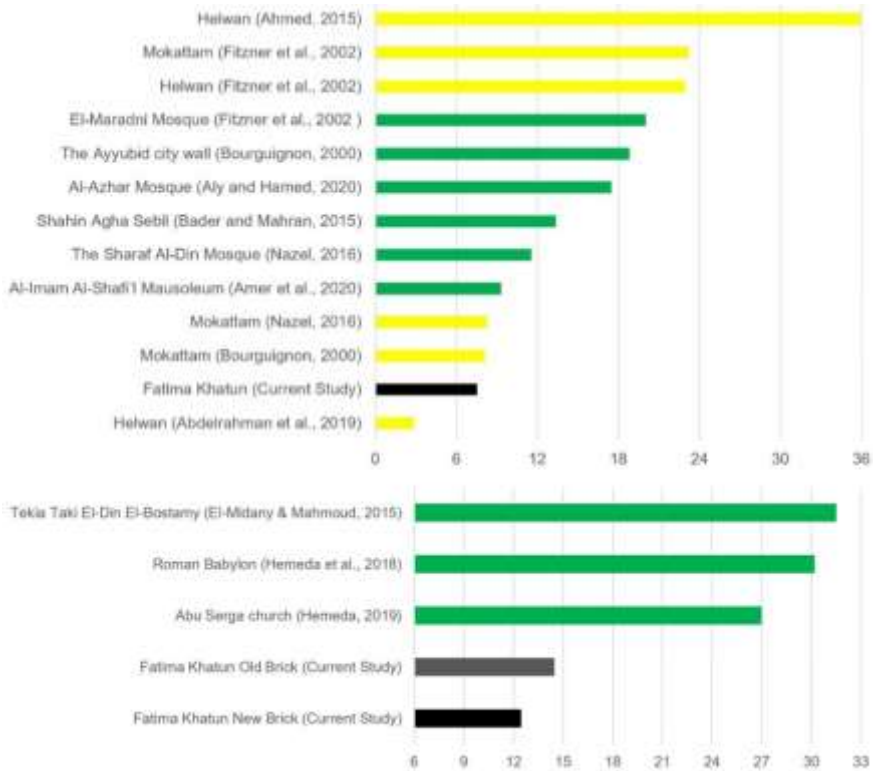
Fig. 13. Comparison of the porosity (%) with the literature for the limestone (top) and the brick (bottom).

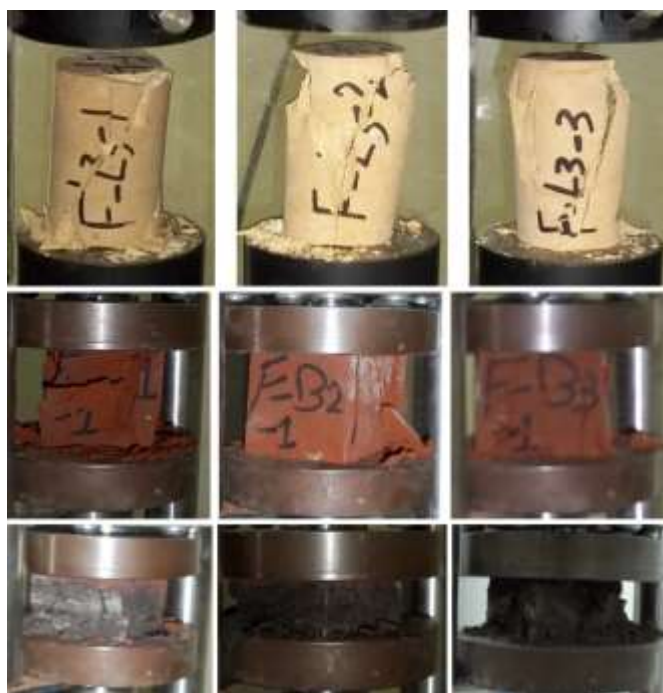
Fig. 14. Failure of the samples in the compressive strength test: The limestone (top), the new brick (bottom), and the old brick (bottom)

The new brick had almost three times the compressive strength of the old brick (15.75 MPa compared to 5.48 MPa). Also, the CV was lower (20.6% compared to 35.9%). The old brick showed axial splitting failure mode (Fig. 14, middle), whereas the new brick was crushed into coarse to fine powder (Fig. 14, bottom). The advanced state of deterioration of the old brick contributed notably to its showing such a mode of failure and low compressive strength.
