INTEGRATED DYNAMIC AND THERMOGRAPHY INVESTIGATION OF MALLORCA CATHEDRAL

Ahmed Elyamani¹, Oriol Caselles², Pere Roca² and Jaime Clapes²

ABSTRACT

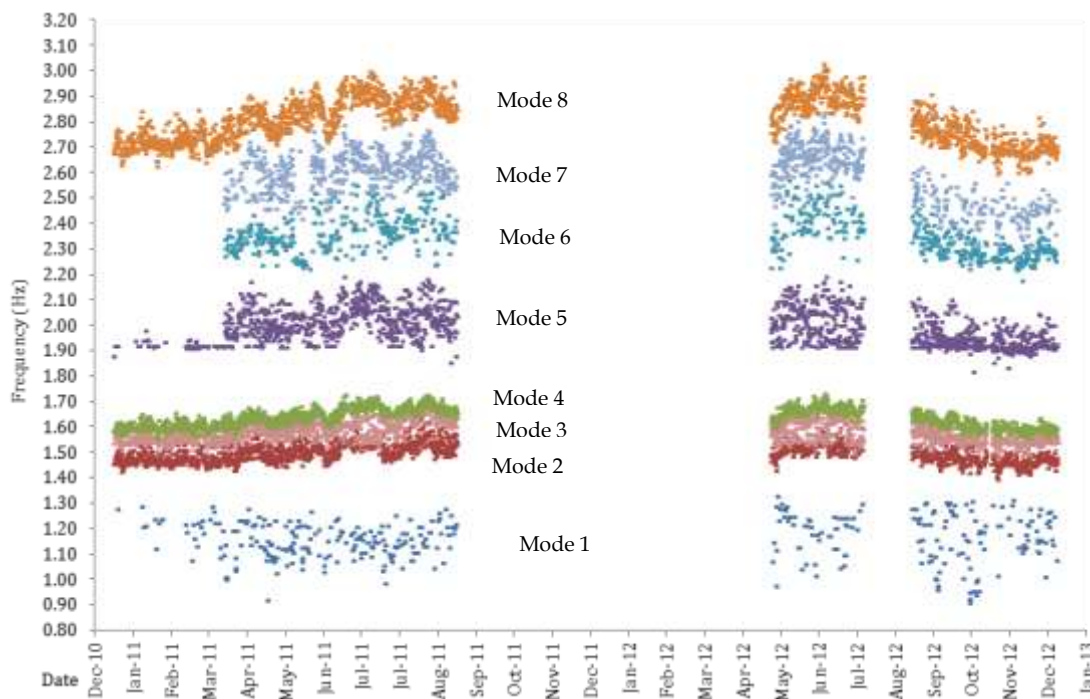
Figure 5. Evolution of the natural frequencies of the cathedral over time.

The eight natural frequencies identified from AVT were identified continuously by the system. The identified natural frequencies were plotted versus the time as presented in Figure 5. The gap in the second period corresponds to the dates previously mentioned during which the system was out of service due to technical problems.

In the first monitoring period, the cathedral natural frequencies showed an increasing trend that can be attributed to the raising of the temperature, since the monitoring started in winter and ended in summer. The contrary was found for the second monitor-

ing period during which a decreasing trend was noticed, also attributed to the temperature variations as the monitoring started in summer and ended in winter.

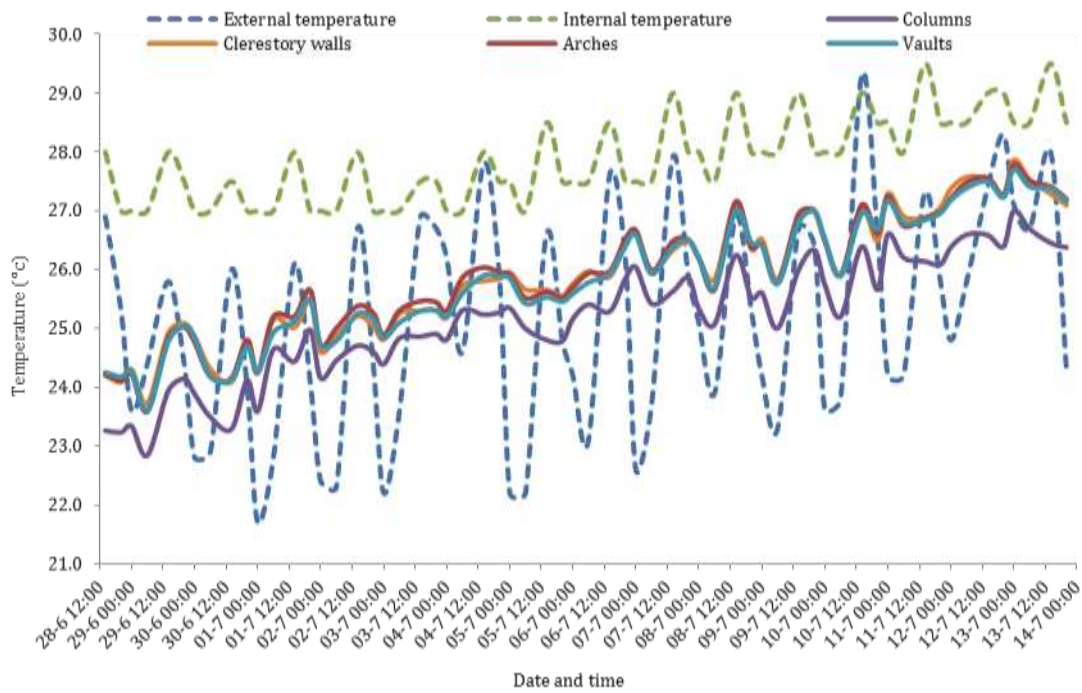
Figure 10. Comparison between external, internal and stone surface temperatures in the summer period from 28/6/2011 to 13/7/2011.

A comparison was made between the external temperature (measured from a near meteorological station), the internal temperature (measured in summer only using temperature sensors) and the stone surface temperature of the considered structural elements for the summer period (Figure 10) and the winter period (Figure 11). It can be seen that the stone surface temperatures of the different struc-

tural elements were in phase and very near to each other for the two monitoring periods. For the summer period, the internal and the external temperatures were in phase, whereas, the stone surface temperature was sometimes delayed with respect to the external and the internal temperatures. In the winter period, the stone surface temperature was in phase with the external temperature.

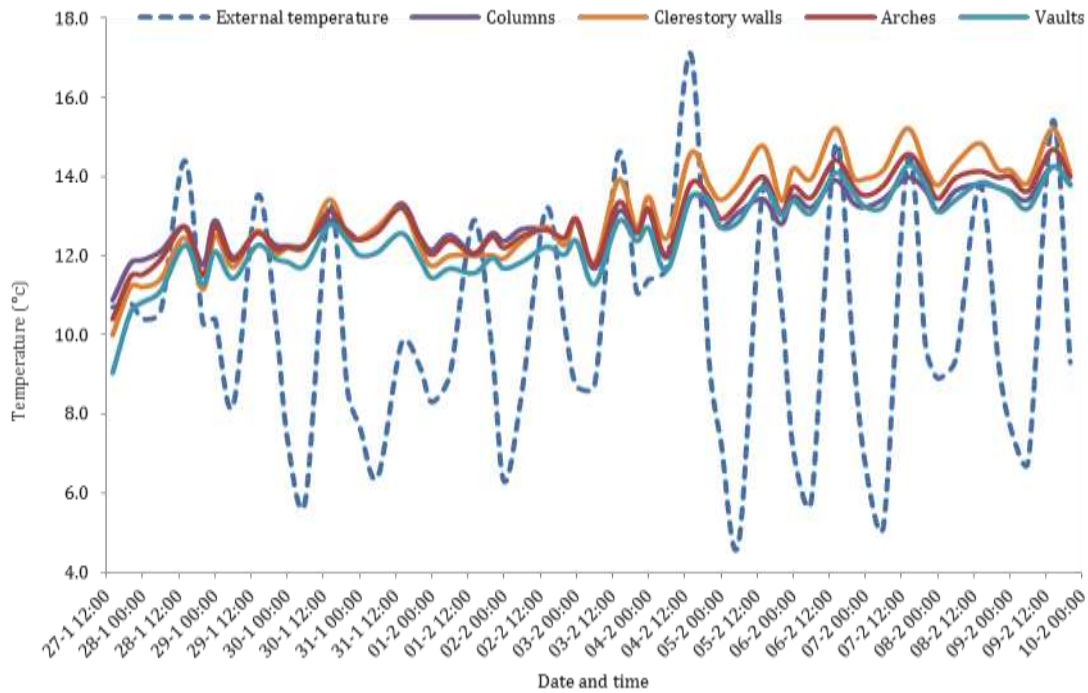
Figure 11. Comparison between external and stone surface temperatures in the winter period from 27/1/2011 to 9/2/2011.
