# Assessment of the potential effects of plants with their secreted biochemicals on the biodeterioration of archaeological stones

Yomna M. Elgohary<sup>1</sup> · Maisa M. A. Mansour<sup>1</sup> · Mohamed Z. M. Salem<sup>2</sup>

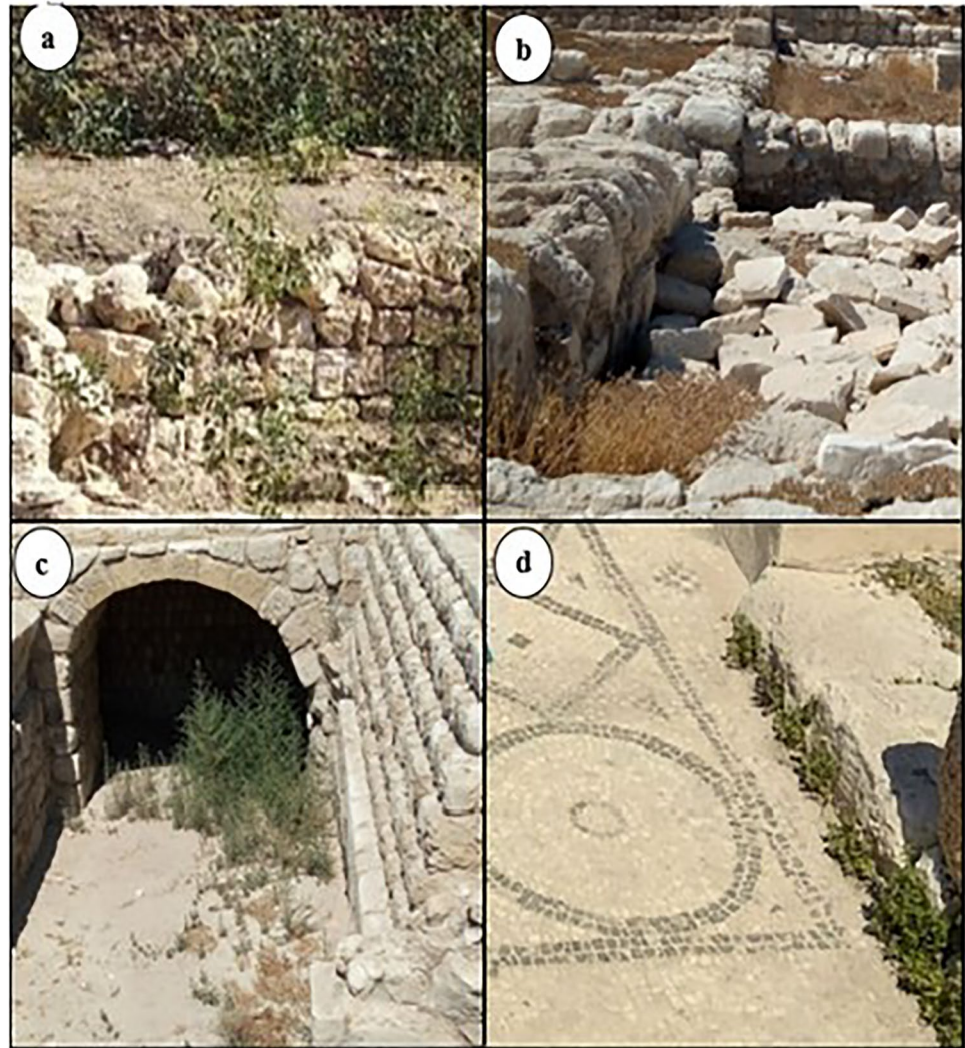
**Fig. 1** An example of plant colonization at Kom el Dikka site Alexandria, Egypt (**a** and **b** showing the growth of the plants between stone blocks, **c** showing plants under the ribbed vault, **d** showing plants growing on the mosaic (Photos were taken by the co-author Yomna M. Elgohary)

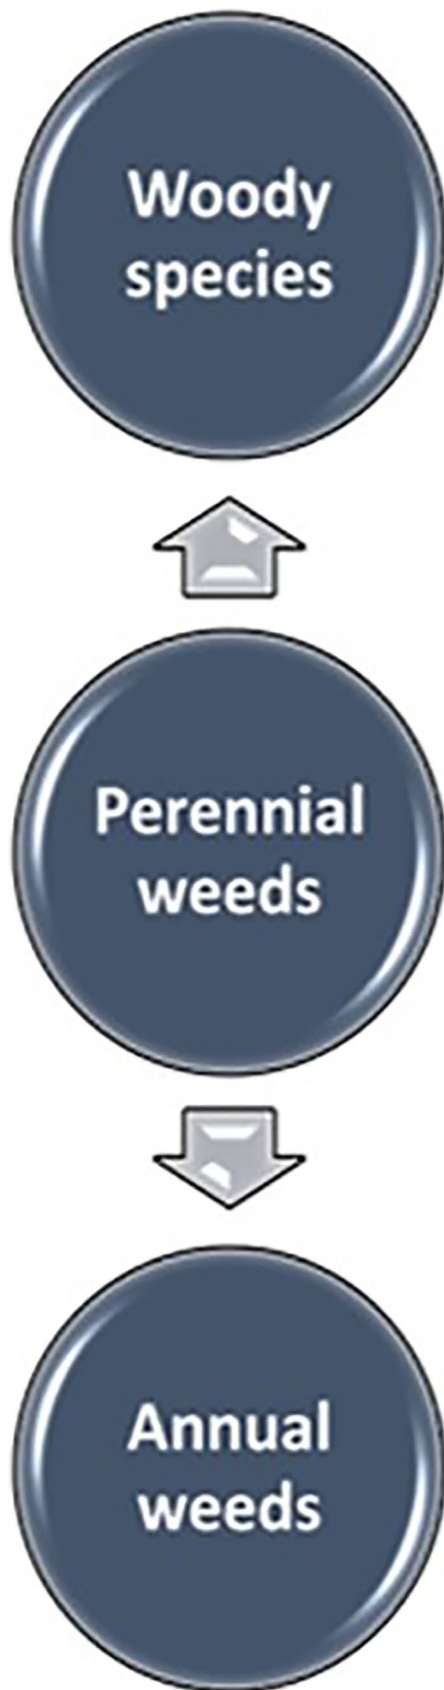
**Fig. 2** The order of the most harmful plant species

Likewise, ivy roots can be very invasive and destructive when allowed to penetrate pre-existing fissures and gaps [45]. Moreover, ivy can interact with brick and mortar causing loss of structural integrity and by extension, intervention by the consolidation process becomes required [22]. Overall, vines should be denied the freedom to climb the walls, which could be achieved by periodic weed trimming maintenance [15, 24–28]. The order of the most harmful plant species is shown in Fig. 2.
