## EVALUATION OF SULPHATE ACTIVATORS AS CONSOLIDANTS FOR THE TRANSFORMED GYPSUM IN HISTORIC STUCCO

### Abstract

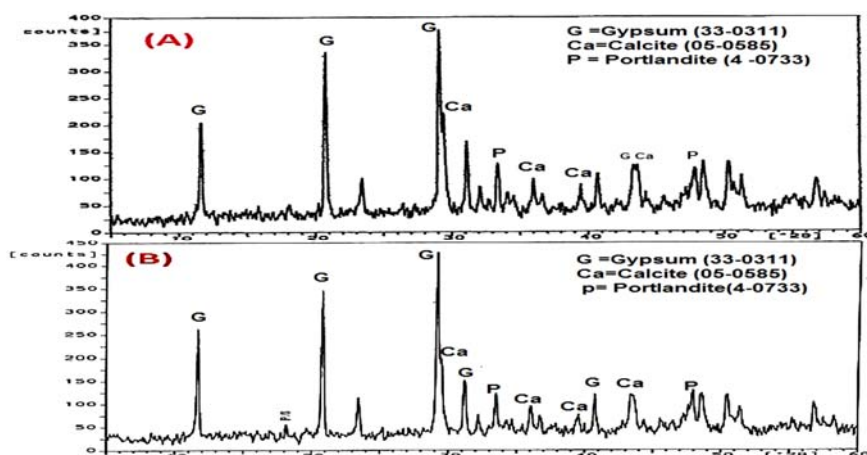
**Fig. 1.** X-Ray diffraction patterns of the gypsum lime stucco samples after 10 months of room atmospheric conditions exposure, most of portlandite ratio was converted to calcium carbonate.

The X-ray diffraction patterns of the gypsum lime stucco samples (which were prepared for the experimental study) after 10 months of exposure to room atmospheric conditions indicate that most of the portlandite ratio was converted to calcium carbonate as a result of the surrounding atmosphere, especially carbon dioxide gas (Fig. 1). The XRD results were proved by the results of FTIR analysis, (Fig. 2). The comparison between the bands of  $1437\text{cm}^{-1}$  with  $1426\text{cm}^{-1}$  and the band  $872\text{cm}^{-1}$  with  $874\text{cm}^{-1}$  allows the identification of  $\text{CaCO}_3$  and the increase of its ratio after 10 months.

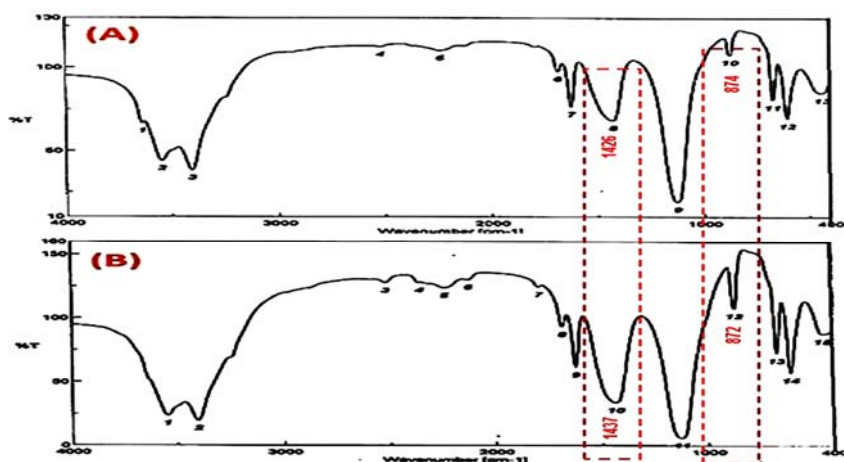
Fig. 2. FTIR spectra from the gypsum lime stucco samples (A) after 1 month (B) after 10 months, bands related to  $\text{CO}_3$  prove the results of XRD analysis.

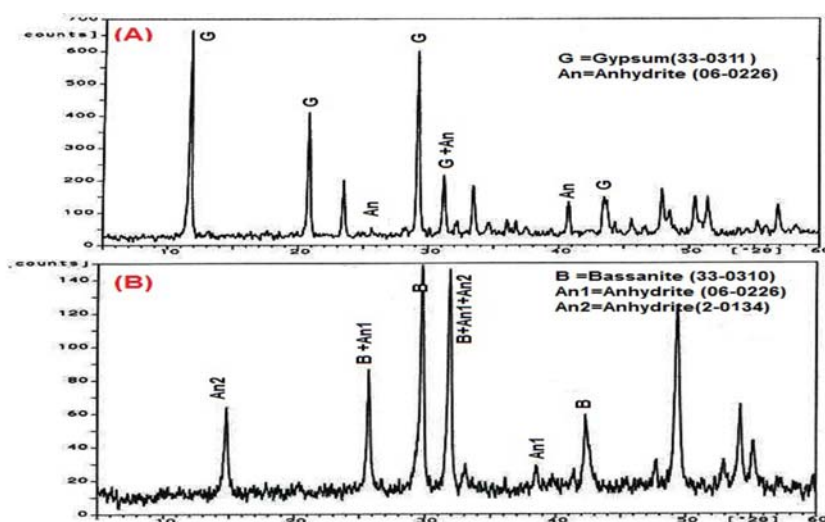
Fig. 3. The X-ray diffraction pattern of the gypsum stucco samples that were exposed to a temperature of  $300^\circ\text{C} \pm 10$  for six hours, in comparison with the non-heated gypsum sample. The figure shows the transformation of gypsum content to anhydrite and other intermediate phases of gypsum.

The X-ray diffraction patterns of the gypsum and gypsum lime stucco samples that were exposed to temperature degree  $300^\circ\text{C} \pm 10$  for six hours, in comparison with the non-heated samples show the transformation of gypsum content to anhydrite and other intermediate phases of gypsum (Figs. 3 and 4). After this point of transformation, the samples were ready for the application of sulphate activators solutions.

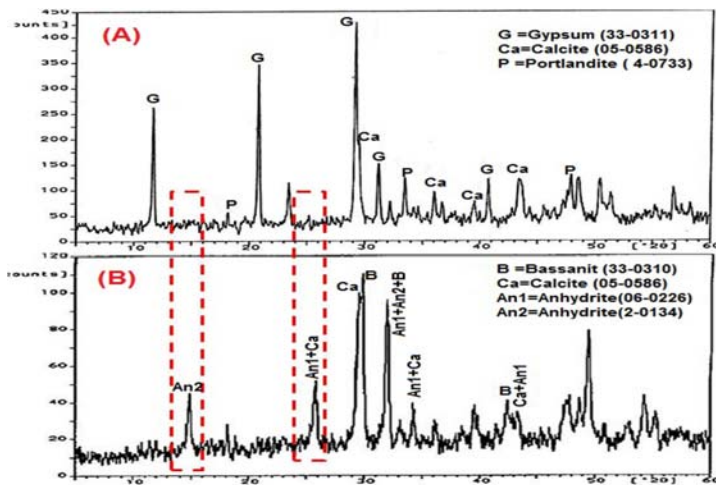
**Fig. 4.** The X-ray diffraction pattern of the gauged stucco samples which were exposed to a temperature of  $300^{\circ}\text{C} \pm 10$  for six hours, in comparison with the non-heated gauged sample, the figure shows the transformation of gypsum content to anhydrite and other intermediate phases of gypsum.

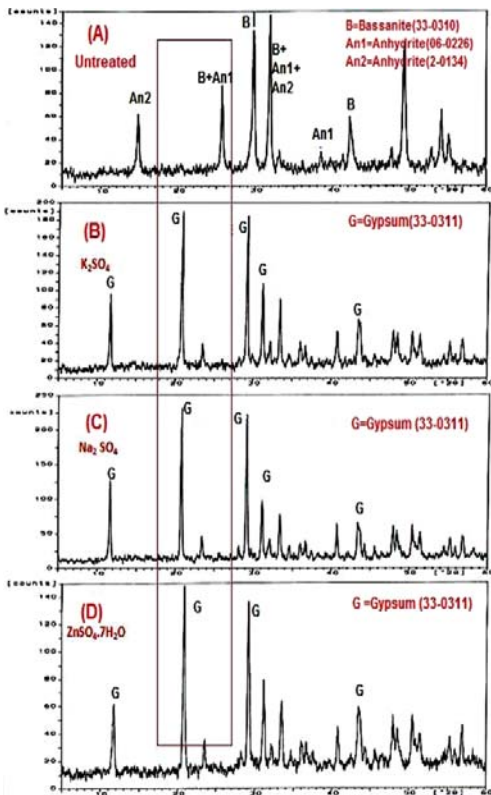
**Fig. 5.** The X-ray diffraction patterns of the treated gypsum stucco samples with the selected sulphate activators solutions, after more than 28 days, in comparison with the untreated sample, the patterns indicate the appearance of gypsum and the approximate disappearance of anhydrite

The X-ray diffraction patterns of the treated gypsum and gypsum lime stucco samples with the selected sulphate activators solutions (after more than 28 days in comparison with the untreated samples) showed the appearance of gypsum and the approximate disappearance of anhydrite (Figs. 5 and 6) that emphasized the ability of the selected sulphate activators solutions to retransform anhydrite to gypsum, which may increase the strength of the stucco samples. Fortunately, none of the three compounds; potassium carbonate, sodium carbonate or zinc carbonate, was detected in the X-ray diffraction patterns of the treated samples, which decreases the possibility of formation of harmful salts, or reaction of sulphate activators with the other components of the stucco, such as calcium carbonate.

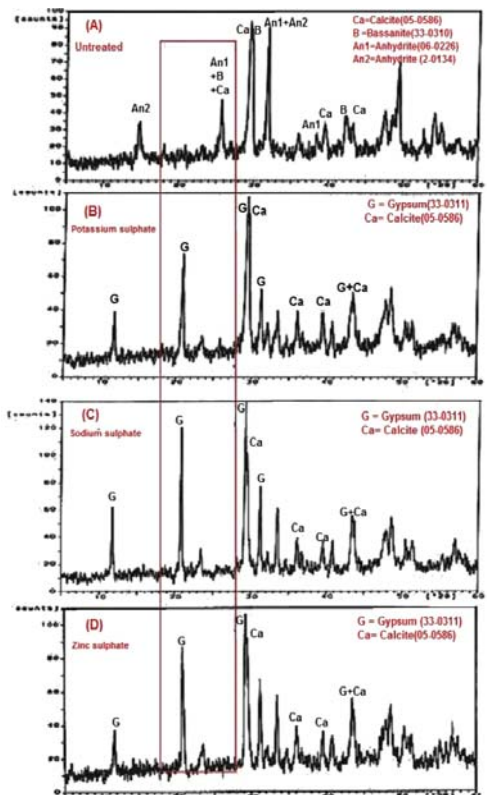
**Fig. 6.** The X-ray diffraction patterns of the treated gauged stucco samples with the selected sulphate activators solutions, after more than 28 days, in comparison with the untreated sample, the patterns indicate the appearance of gypsum and the approximate disappearance of anhydrite

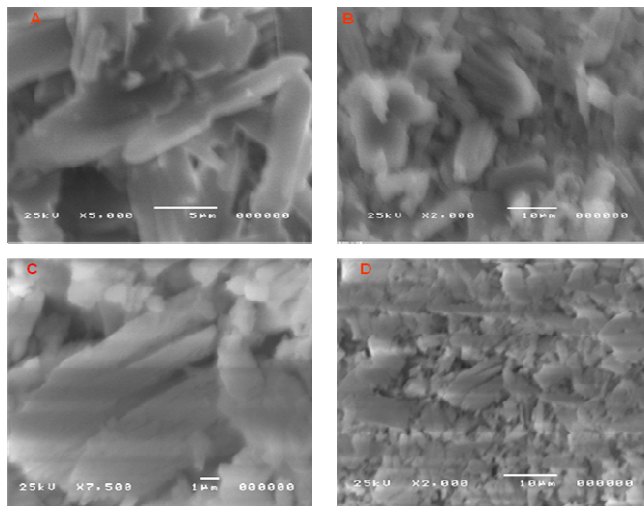
**Fig. 7.** SEM micrographs of the standard gypsum stucco samples: A & B untreated and non-aged gypsum stucco samples, needle-like crystals relate to gypsum crystals, C & D untreated and aged gypsum stucco samples, the noticeable difference in most of the crystal forms may be related to the transformation to anhydrite as a result of heating at  $300^{\circ}\text{C} \pm 10$ .

The observations made by using SEM for the treated gypsum stucco samples showed the appearance of interlocked needle-like crystals, which may be related to the reformation of gypsum crystals in all the treated gypsum stucco samples with the selected sulphate activators (Figs. 7 and 8). This may cause an increase of cohesion among crystals (that will be proved by measurement of the physical and mechanical properties), also, in the micrographs of the treated gauged stucco samples with the selected sulphate activators, the appearance of some elongated crystals may be related to the reformation of gypsum crystals (Figs. 9 and 10). However, in the samples treated with  $\text{Na}_2\text{SO}_4$ , some mineral crystals were found among the elongated gypsum crystals may be related to the formation of sodium chloride crystals as proved by XRD analysis (Fig. 8C and 8D; Fig. 10C and 10D).

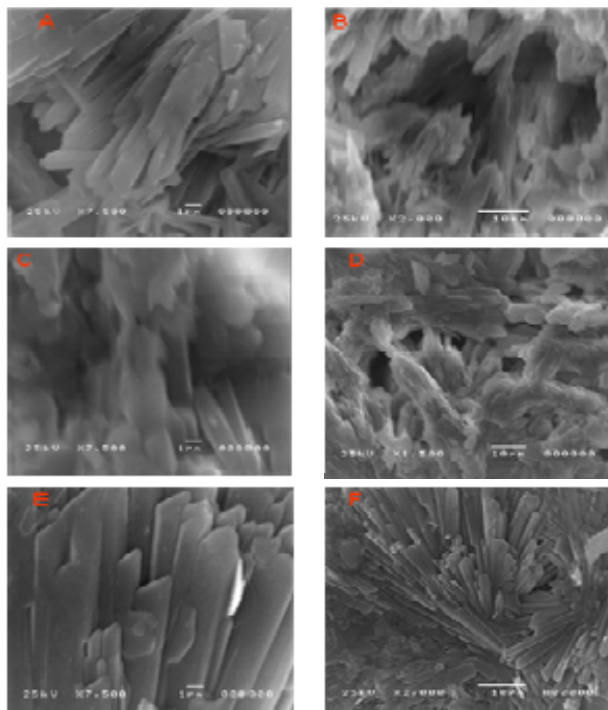
**Fig. 8.** SEM micrographs of the treated gypsum stucco samples with the selected sulphate activators. A & B, aged gypsum stucco samples after treating with  $\text{K}_2\text{SO}_4$ , the interlocked needle-like crystals relate to the reformation of gypsum crystals, C & D, aged gypsum stucco samples after treating with  $\text{Na}_2\text{SO}_4$ , the interlocked needle like crystals relate to the formation of gypsum crystals, E & F aged gypsum stucco samples after treatment with  $\text{ZnSO}_4 \cdot 7\text{H}_2\text{O}$ , again, needle-like crystals relate to the formation of gypsum crystals.

| Samples | |
|---|---|
| Compressive strength of dry and wet stucco samples | All treated stucco samples achieved mechanical properties (compressive strength of wet and dry stucco samples) average greater than the aged stucco samples (Figs. 14 and 15), especially $K_2SO_4$ and $Na_2SO_4$ that may be due to retransformation of anhydrite to gypsum. But the strength increasing ratio in $ZnSO_4 \cdot 7H_2O$ gypsum stucco samples was very low, and that may be related to the non-interlocked gypsum crystals (Fig. 8E and F). |

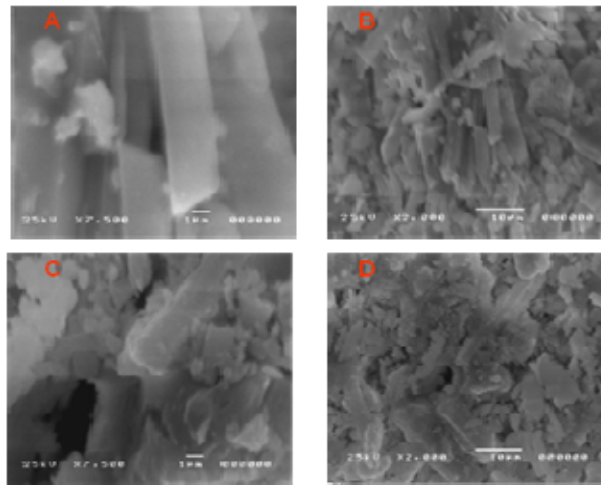
**Fig. 9.** SEM micrographs of the standard gypsum lime stucco samples: A and B untreated and non-aged gypsum lime stucco samples, needle-like crystals relate to gypsum crystals, C and D untreated and aged gauged stucco samples, the noticeable differences in most of crystal forms may be related to the transformation to anhydrite as a result of heating at  $300 \pm 10^\circ\text{C}$ .

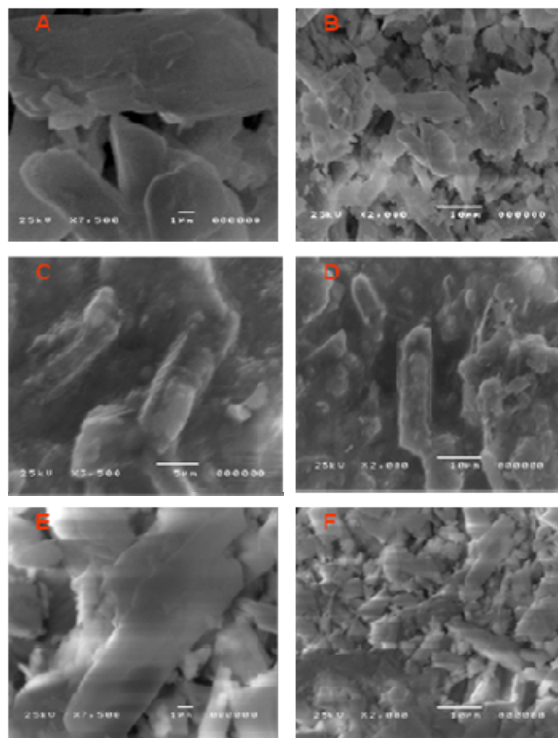
**Fig. 10.** SEM micrographs of the treated gauged stucco samples with the selected sulphate activators: A and B, aged gauged stucco samples after treating with  $\text{K}_2\text{SO}_4$ , some elongated crystals may be related to the formation of gypsum crystals, C and D, aged gypsum lime stucco samples after treating with  $\text{Na}_2\text{SO}_4$ , something among the elongated gypsum crystals may be related to the reformation sodium chloride crystals as proved by XRD analysis. E & F aged gypsum lime stucco samples after treating with  $\text{ZnSO}_4 \cdot 7\text{H}_2\text{O}$ ; also, some elongated crystals may be related to the formation of gypsum crystals.

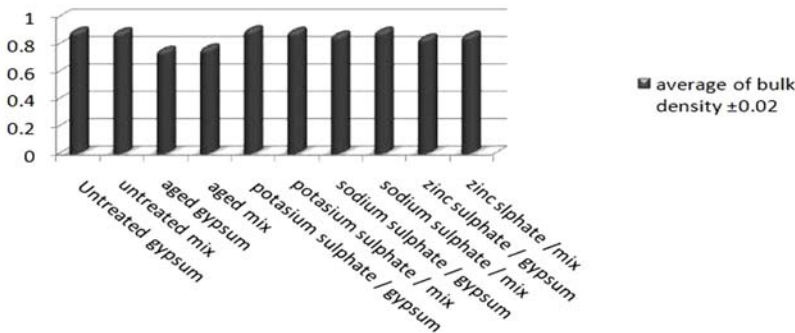
**Fig. 11.** All stucco samples achieved a bulk density average greater than the aged stucco samples, which may be a result of retransformation of anhydrite to gypsum.

| Samples | |
|---|---|
| Bulk density | All treated stucco samples achieved bulk density average greater than the aged stucco samples, which may be a result of retransformation of anhydrite to gypsum (Fig. 11) |

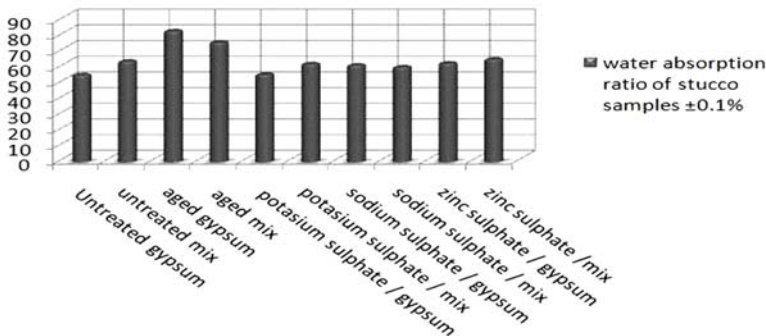
**Fig. 12.** All stucco samples achieved average water absorption less than the aged stucco samples.

| Samples | |
|---|---|
| Water absorption ratio | All treated stucco samples achieved average water absorption less than the aged stucco samples (Fig. 12). |

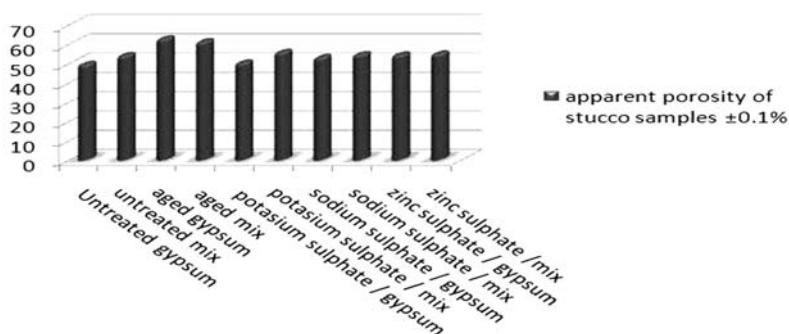
Fig. 13. All stucco samples achieved average of water absorption and apparent porosity less than the aged stucco samples.

| Samples | |
|---|---|
| Apparent porosity | All treated stucco samples achieved average of apparent porosity less than the aged stucco samples (Fig. 13). |

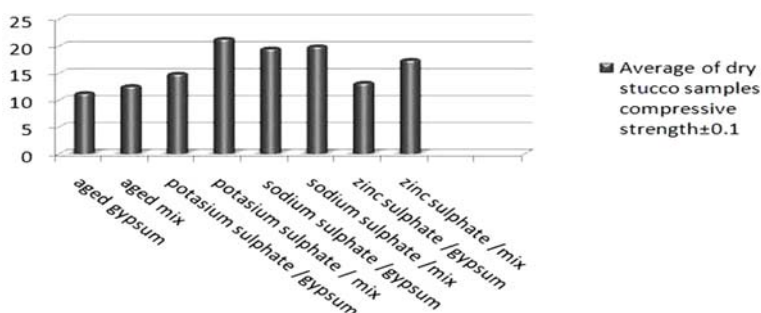
Fig. 14. All stucco samples achieved average of compressive strength of dry stucco samples greater than the aged stucco samples, which may be a result of retransformation of anhydrite to gypsum. The increasing ratio in  $\text{ZnSO}_4 \cdot 7\text{H}_2\text{O}$  gypsum stucco samples was very low, that may be due to the non-interlocked gypsum crystals.

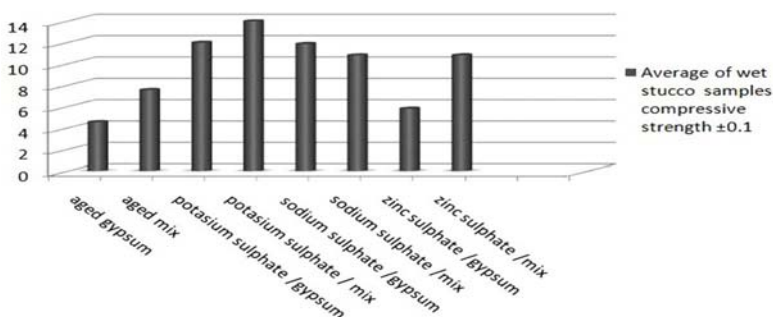
Fig. 15. All stucco samples achieved average of compressive strength of wet stucco samples more than the aged stucco samples, especially  $\text{K}_2\text{SO}_4$  and  $\text{Na}_2\text{SO}_4$ , which may be a result of retransformation of anhydrite to gypsum. The increasing ratio in  $\text{ZnSO}_4 \cdot 7\text{H}_2\text{O}$  gypsum stucco samples was very low, and may relate to the non-interlocked gypsum crystals.

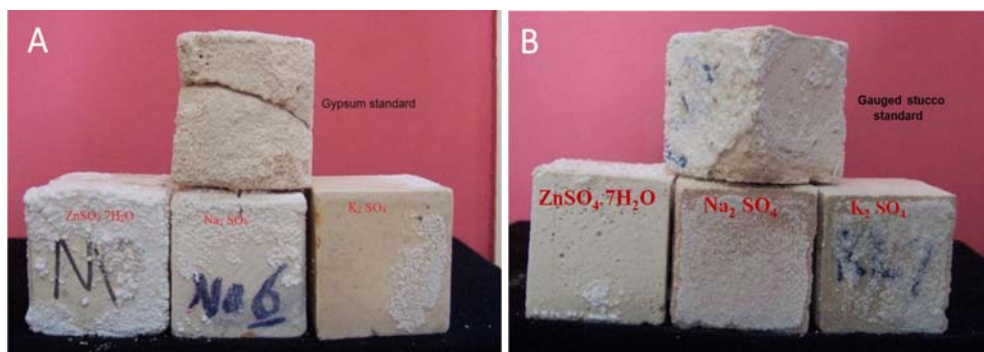
**Fig. 16.** Photographs show the effect of sodium chloride aging cycles on gypsum and gypsum lime stucco treated samples with the selected sulphate activators in comparison with the aged standard samples.

The effect of sodium chloride aging cycles on gypsum and gypsum lime treated stucco samples with the selected sulphate activators in comparison with the aged standard samples showed an improvement in the appearance of the treated samples, especially, samples that were

treated with  $K_2SO_4$ , but without preventing salt efflorescence; this means that sulphate activators don't close the pores of the samples but decrease them (Fig. 16).
